St Bede's School – Drainage Works Case Study

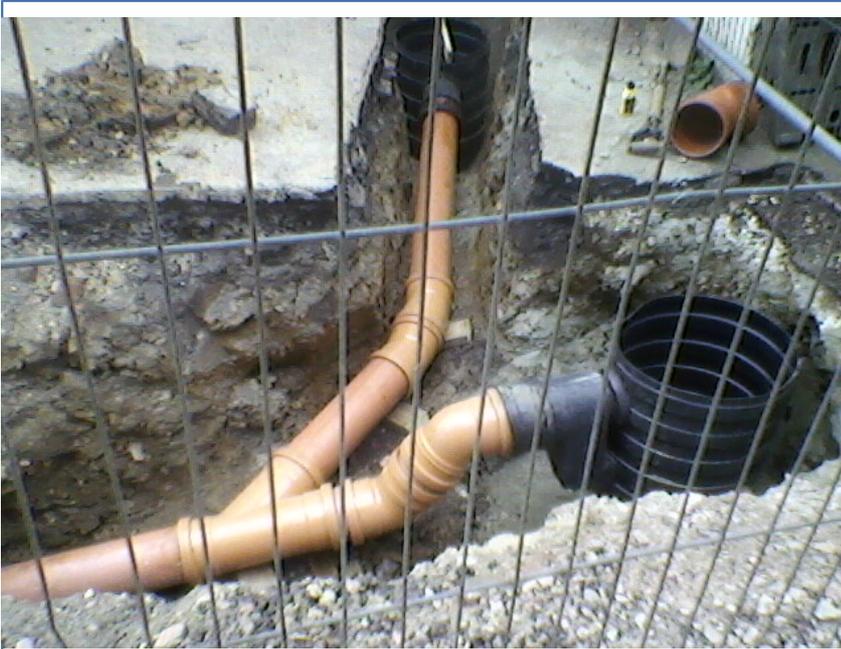
Shallow trench dug to expose gully pots

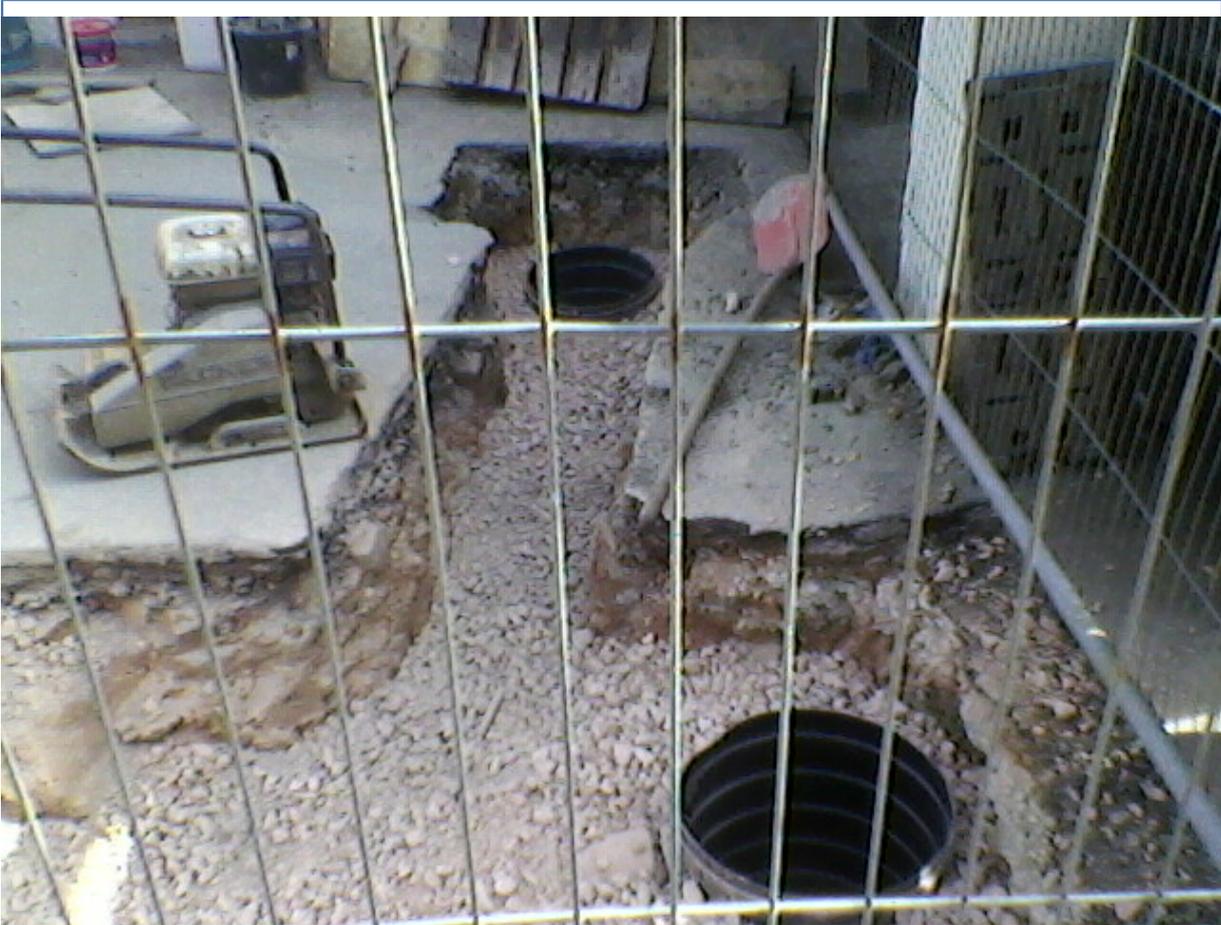
Work in progress at St Bede's School
