Tunnelling & Sewer Connection Case Study

Power + Line (P+L) installed a sewage outfall to a housing development in Purley, Surrey. This outfall was unconventional due to the position of the existing main foul sewer, which ran under a busy bus route. Undertaking the work required driving a hand-dug tunnel / heading of 15 metres into a chalk embankment at an average depth of 7 metres to connect to the main sewer.

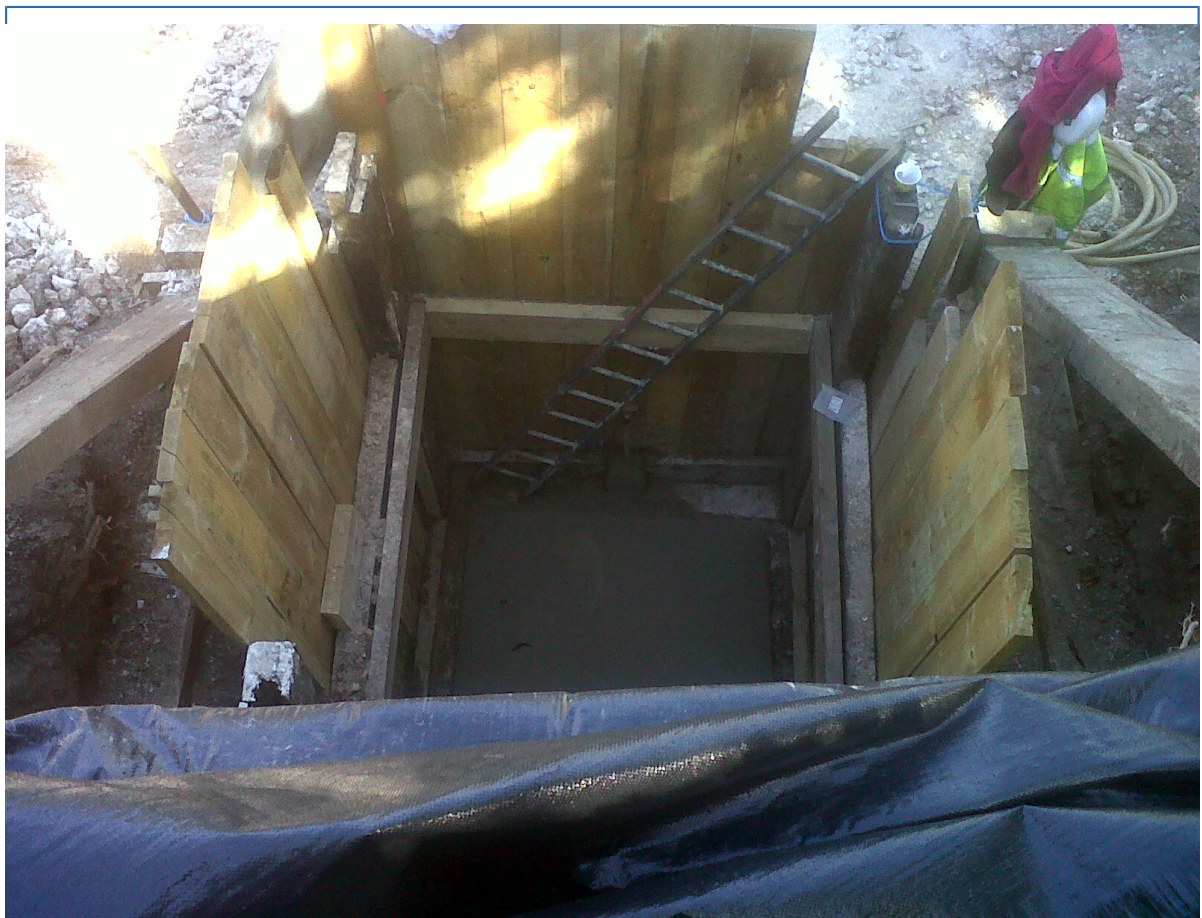
Service shaft with crash deck

We calculated the intercept position and depth of the existing sewer from the results of the survey. This provided the information we needed to sink the service shaft in the property adjacent to the road containing the sewer. Initially, a 4 metre x 3 metre shaft was dug by a 6 tonne hydraulic excavator. This machine also assisted in the installation of heavy baulk timbers and a timber shoring box into the excavation.

Due to the loading restrictions on the bank of the excavation the largest allowable machine did not have an arm long enough to fully reach the required depth of the excavation. A crash deck protection landing was fitted to the shoring structure and the excavation was completed by hand, with the spoil lifted out in mini skips by the excavator. Operatives carrying out this work were regularly briefed on the dangers of working in confined spaces and always carried their air monitors and emergency escape kits with them. We also had fans on the surface, mounted near the shaft entrance to force fresh air into the excavation.

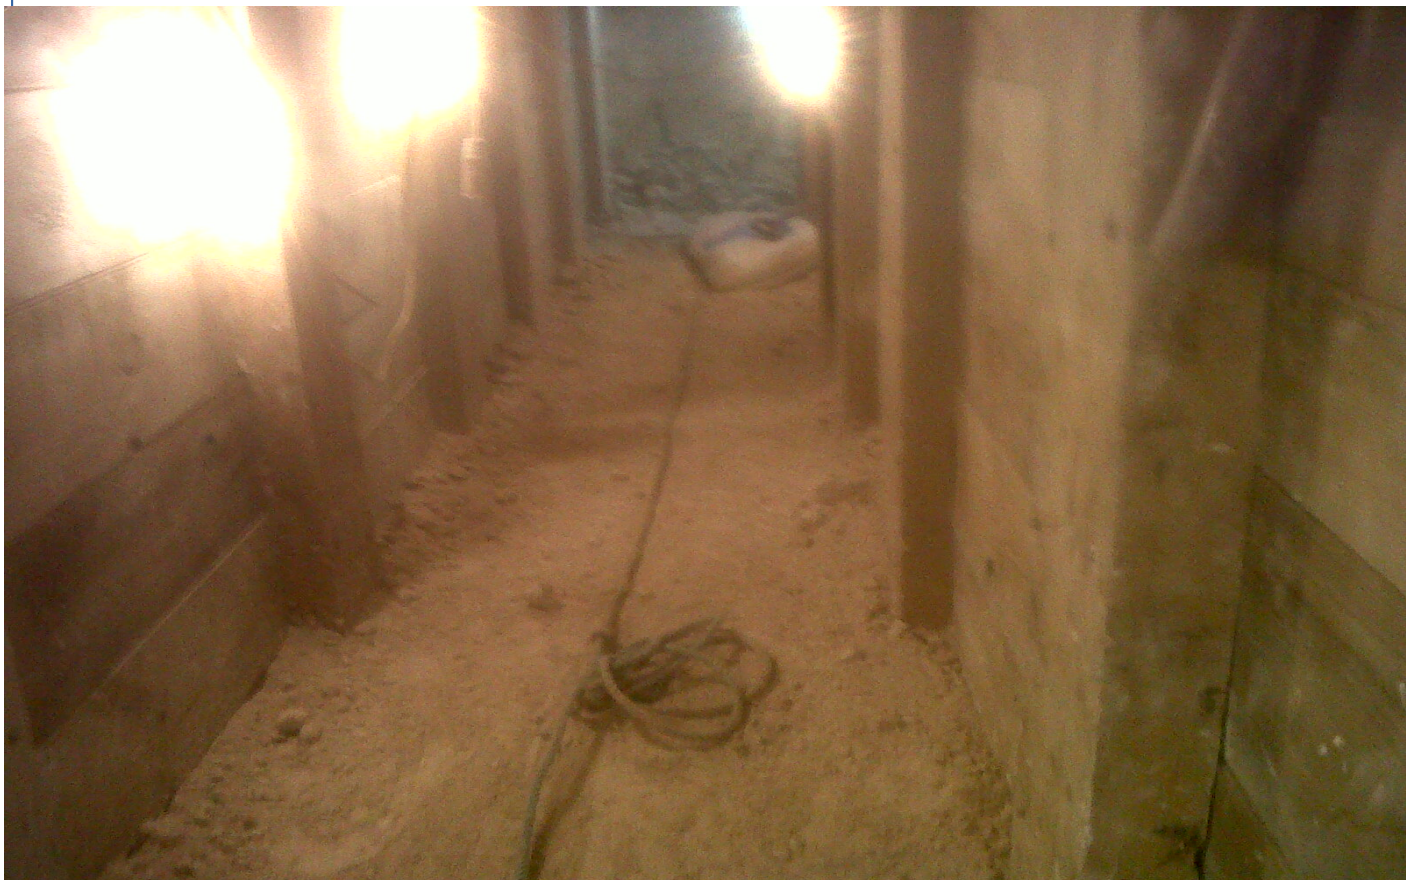
Tunnel formed to access main sewer

Once the required depth had been achieved in the service shaft, a concrete floor with sump was installed and a large opening formed in the shaft wall. This formed the entrance into the chalk face of the horizontal shaft that was to be driven by hand to meet the 9" trunk sewer pipe. Operatives then excavated into the face of the shaft. About every 0.500m as the shaft progressed a timber bearer was installed on the floor of the tunnel, 2 No 6" x 3" timbers (bites) fixed with timber screws vertically from this and a 6" x 3" timber (head tree) placed on top of these. When two of these structures were constructed the intervening space between the bites was made up

with 6" x 1" timber planks. These were placed behind the bites and the resulting void filled with excavated material and compacted by hand until the ceiling was reached. Similarly, 6" x 1" boards were fitted between the head trees, spanning the roof of the tunnel. The void here was also packed with excavated material to eliminate voids behind the timber tunnel support. These timbers were treated and are guaranteed to last 100 years underground.

This process was repeated until the 9" main trunk sewer was exposed, with the excavated spoil being removed from the tunnel shaft via a light rail bogey system.
